## **Report on Lot Classification and Salinity Assessment**

**Proposed Residential Subdivision**

**Light Green - Cobbitty Road, Cobbitty NSW**

**Project 92323.21**

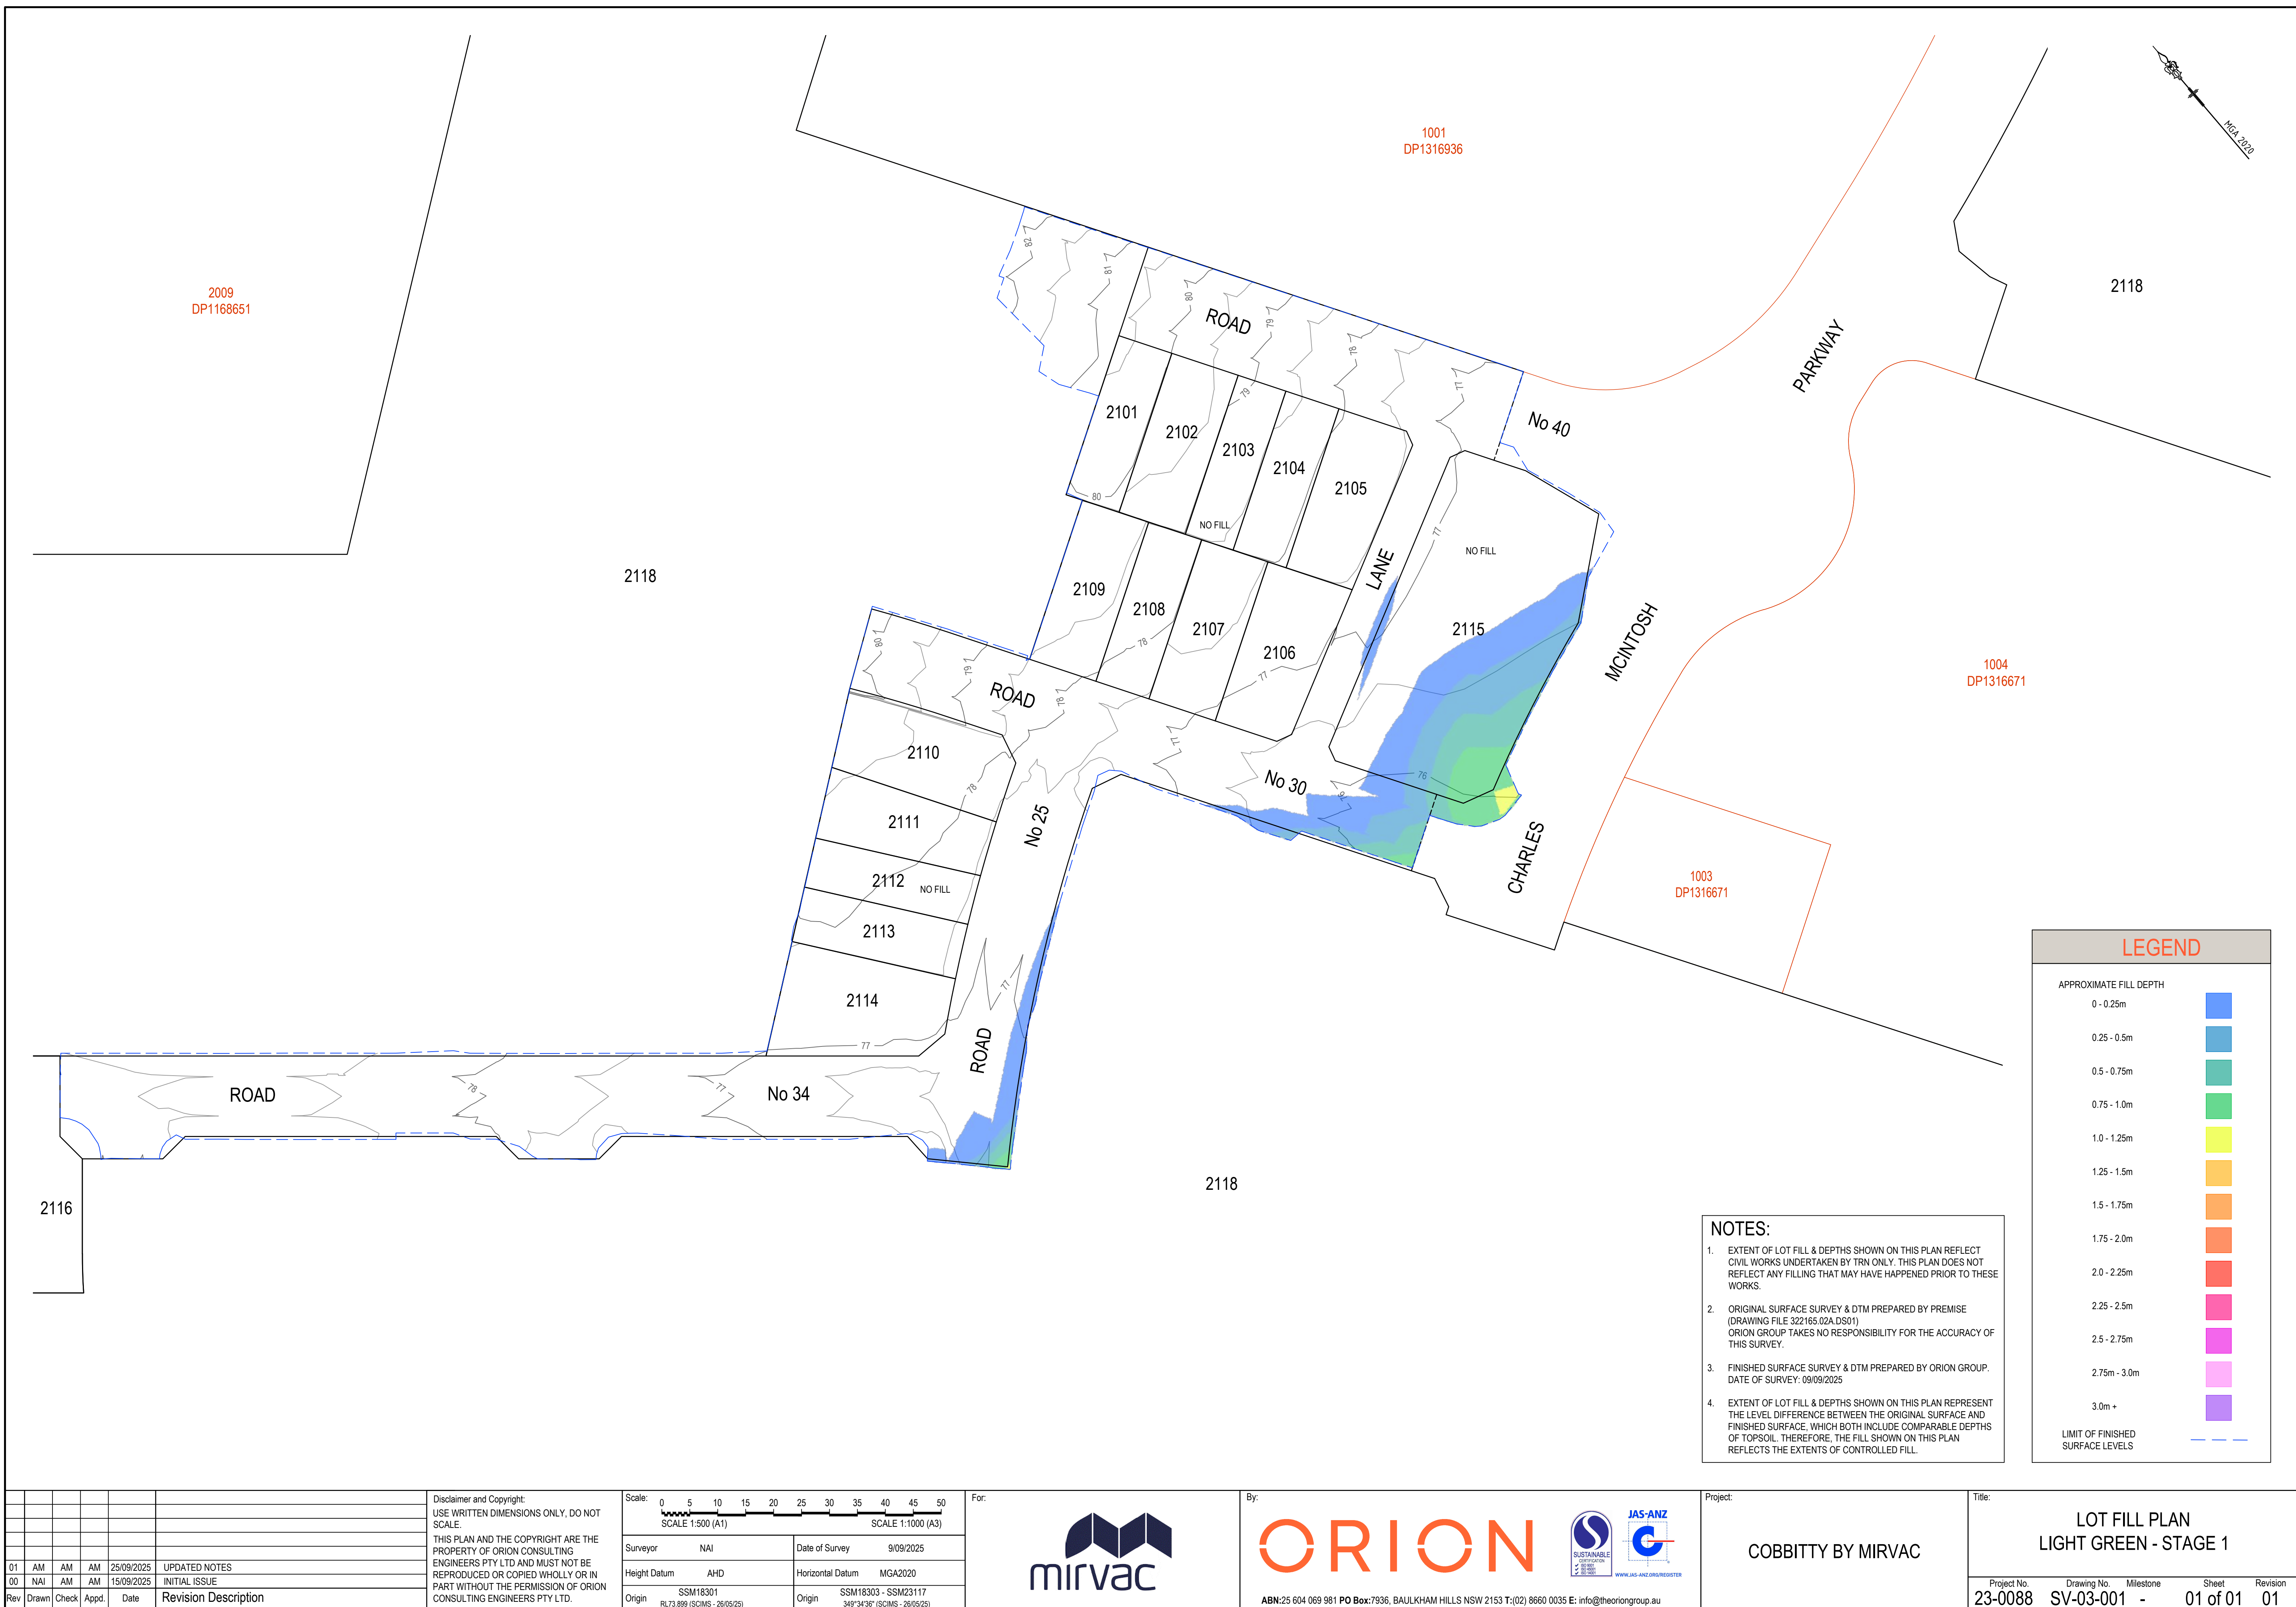
NOTES:

1. EXTENT OF LOT FILL & DEPTHS SHOWN ON THIS PLAN REFLECT CIVIL WORKS UNDERTAKEN BY TRN ONLY. THIS PLAN DOES NOT REFLECT ANY FILLING THAT MAY HAVE HAPPEN PRIOR TO THESE WORKS.

**Attachments:** Works-as-executed fill plans (prepared by Orion Group)  
Drawing 1 – Density test location plan  
Density test results  
About this Inspection Report
